THE HIDDEN DANGER – ROOF TRUSSES

BY: paramedicgirl999

The danger of wood trusses

Long Span Roof Trusses

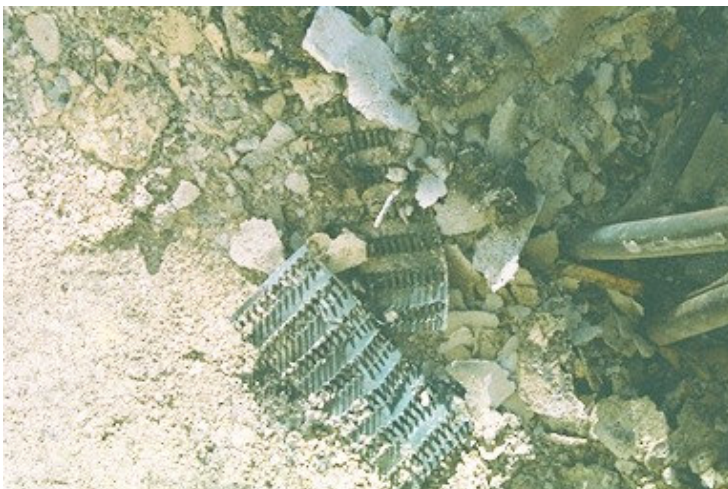
These metal connectors have short teeth that bite into the wood, creating a strong, stable connection. In a fire, though, they may help weaken the wood. When the U.S. Forest Products Laboratory conducted limited fire tests on

gusset plates, researchers found that they reflected the heat away from the connection during the initial stages of a fire, but as the fire progressed, they transmitted heat into the wood, charring it.

Examining the wood underneath and next to the plate after the tests, researchers found similar damage and concluded that it wasn't the plate itself that had failed-it was the wood the plate's teeth had penetrated.

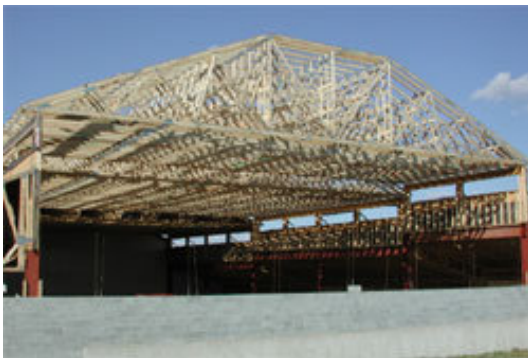
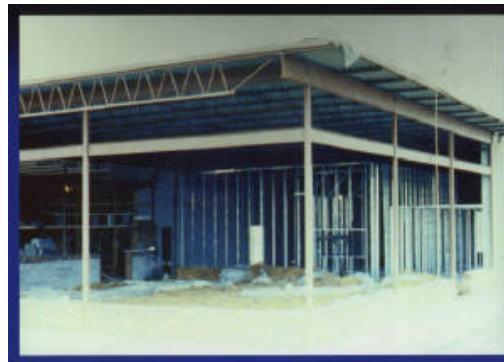
Look at the picture below; if we take one brace out of one truss, we can possibly shift the overall weight, compromising the whole structure.

If we study the arrows, we see that if one small piece is taken away, we could have a catastrophic collapse of the whole truss.

Through the engineering of multiple triangles, weight can be distributed over a vast span, but that span vitally depends on every member of every triangle. If we take away any member in the system, we can have a catastrophic failure of the whole system.

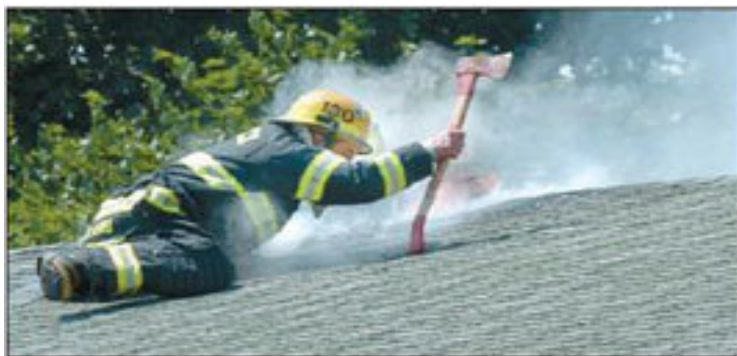
FIREFIGHTER of the West Berwick Hose Co. uses his ax to stop his fall as his left leg and arm break through the roof at 201 Maple Road in Berwick on Wednesday afternoon. Eveland suffered burns on both of his hands in the mishap during the attic fire. Press Enterprise/Ginny May

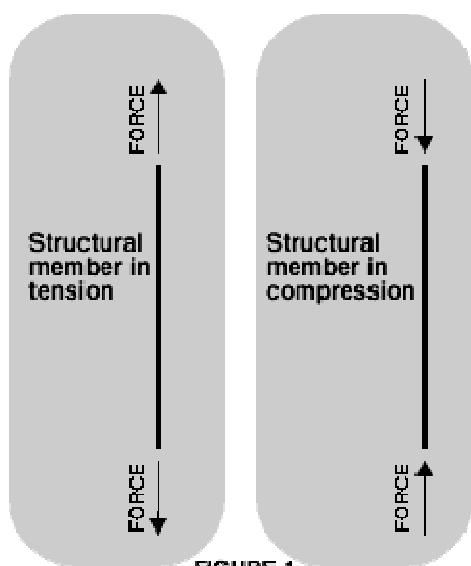
FIGURE 1

A roof truss is made of several pieces of wood that are joined together. Each piece of the truss is referred to as a "member". A brace is a member that prevents a structural element from buckling or racking. Members are generally subjected to tensile or compressive forces. As shown in figure 1, tension forces tend to pull a member apart while compressive forces tend to push a member together.

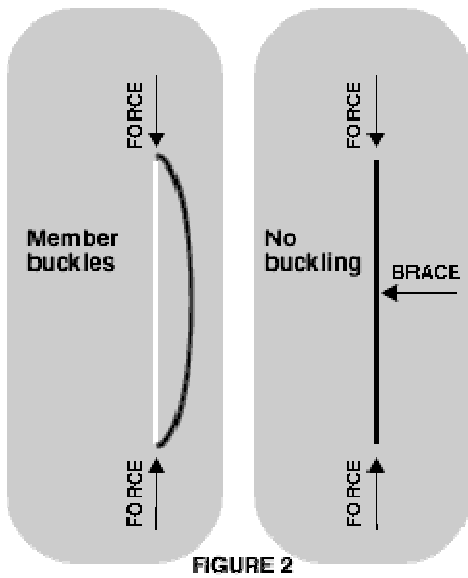
When a compressive force becomes great enough, it will tend to buckle or bow a member as shown in the left side of figure 2. This can be demonstrated by placing a yardstick on end on the floor while holding the upper end. When you push down on the upper end, the yardstick buckles in its narrow direction. The right side of figure 2 demonstrates the use of a brace at the middle of the structural member. Under the same compressive force, the brace prevents the member from buckling. This can be demonstrated by applying the same downward pressure on the yardstick with one hand, while restraining it at the middle with your other hand. The yardstick will not buckle under the same pressure.

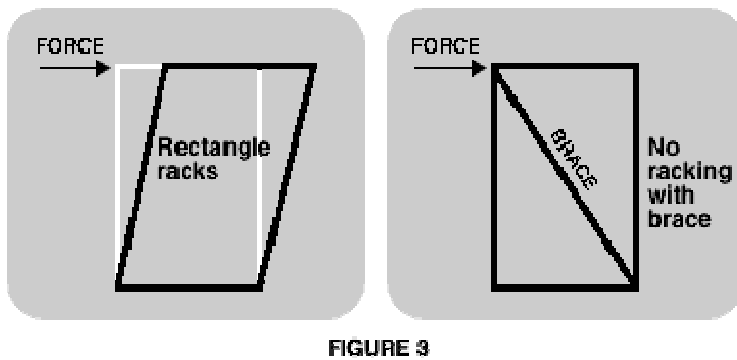
A brace can also be used to prevent structural elements from racking. The left side of figure 3 shows a rectangular structural frame that is racked due to a force applied to its top corner. The right side of figure 3 shows the same rectangular frame with a diagonal brace added to prevent racking when the same force is applied. The triangles formed by the addition of the diagonal brace are the fundamental basis for the structural design of trusses.
